Runway RISKS

Reducing Incursions, Excursions, and Confusion

March 2008

Volume 1
Issue 3

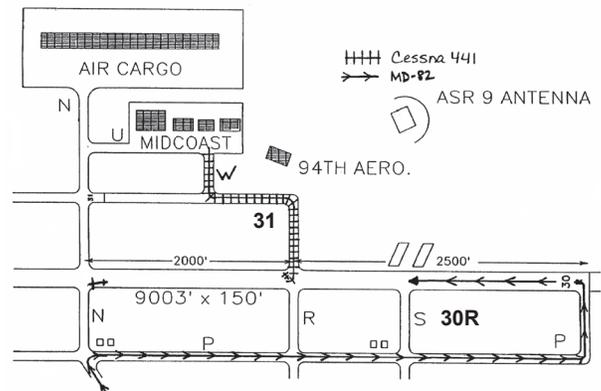
Late in the evening of November 22, 1994, at 2203 Central Standard Time, Trans World Airlines Flight 427, a McDonnell Douglas DC-9-82 (MD-82), collided with a Cessna 441 at the intersection of Runway 30R and Taxiway Romeo, at the Lambert-St. Louis International Airport in Bridgeton, Missouri. The MD-82 was operating as a regularly scheduled passenger flight from STL to Denver, Colorado. There were 132 passengers, five flight attendants, and three flight crewmembers [including a jumpseat occupant] aboard the airplane. The MD-82 sustained substantial damage during the collision. The Cessna 441 was destroyed. A commercial pilot and a passenger, who were rated as a private pilot, were the sole occupants

Following is an excerpt from the National Transportation Safety Board's Aircraft Accident Report #95/05, which describes the runway collision of an MD-82 and a Cessna 441 at the intersection of Runway 30R and Taxiway Romeo at the Lambert-St. Louis International Airport in November 1994. The Cessna pilot had been cleared into position and hold on Runway 31, but he mistakenly taxied onto Runway 30R instead and unwittingly became a fatal accident waiting to happen while sitting for several minutes in the darkness on the wrong runway. The MD-82 crew saw the Cessna just moments before impact and veered left, which minimized damage to the airliner, but the right wing sheared off the top of the C441 and instantly killed its two occupants.
