Engineered Materials Arresting System—A Pilot's

By **F/O Steve Jangelis (Delta)**, ALPA's Airport and Ground Environment Group Chairman

Materials Arresting Primer

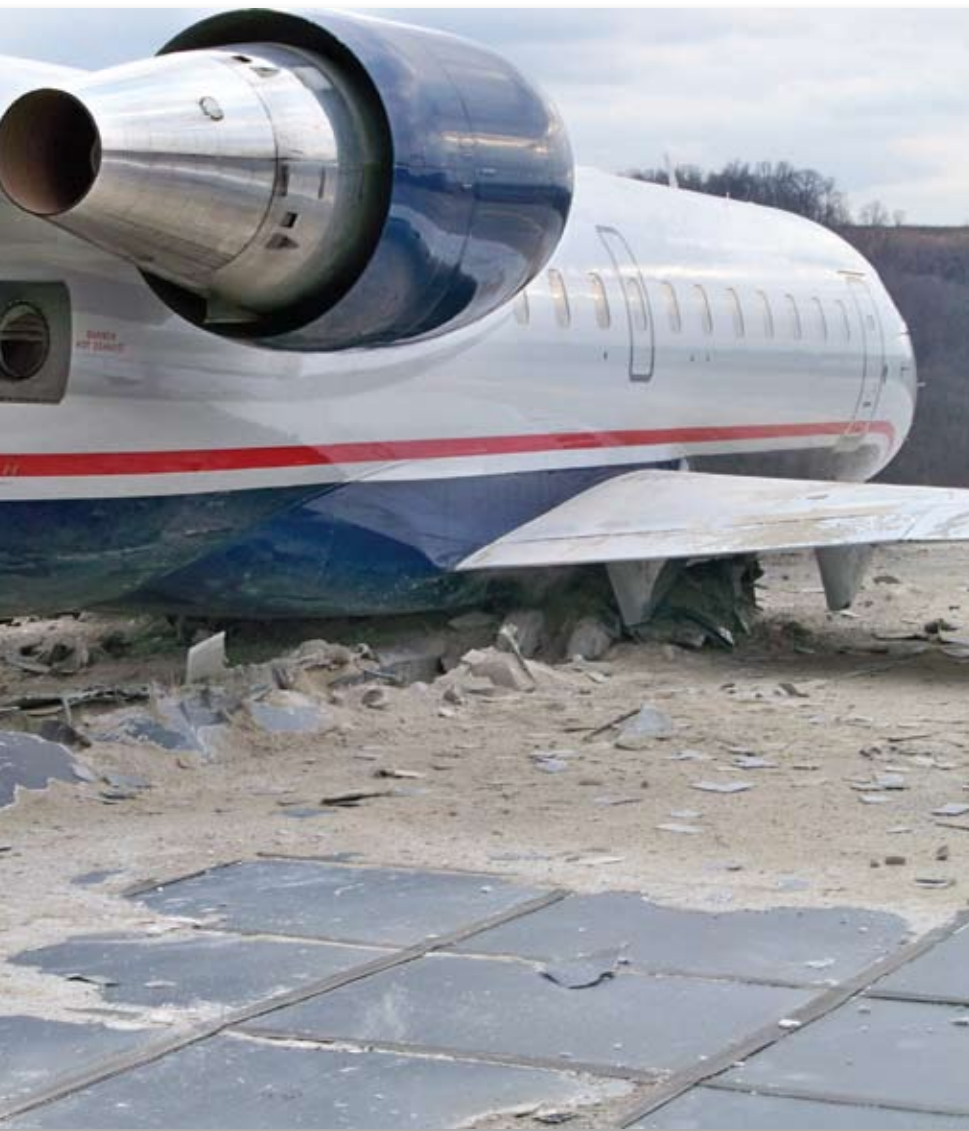
LEFT: A CRJ stops in the EMAS bed's "crushable concrete" at Charleston, W.Va., with only minor damage after a rejected takeoff above V1. ABOVE: Entering an EMAS bed, steer straight ahead.

On Jan. 19, 2010, a regional jet airliner departing Charleston's Runway 23 was involved in a high-speed rejected takeoff. The airplane overran the runway end but was safely brought to a stop by an Engineered Materials Arresting System (EMAS), a bed of crushable concrete installed at the runway's end. The EMAS bed stopped the airplane from descending down a long, steep drop-off and prevented a potential catastrophe. The two pilots, the flight attendant, and their 31 passengers were not injured, and the airplane suffered only minor damage. This was an unfortunate event, but once again EMAS effectively proved its value as a runway safety device.

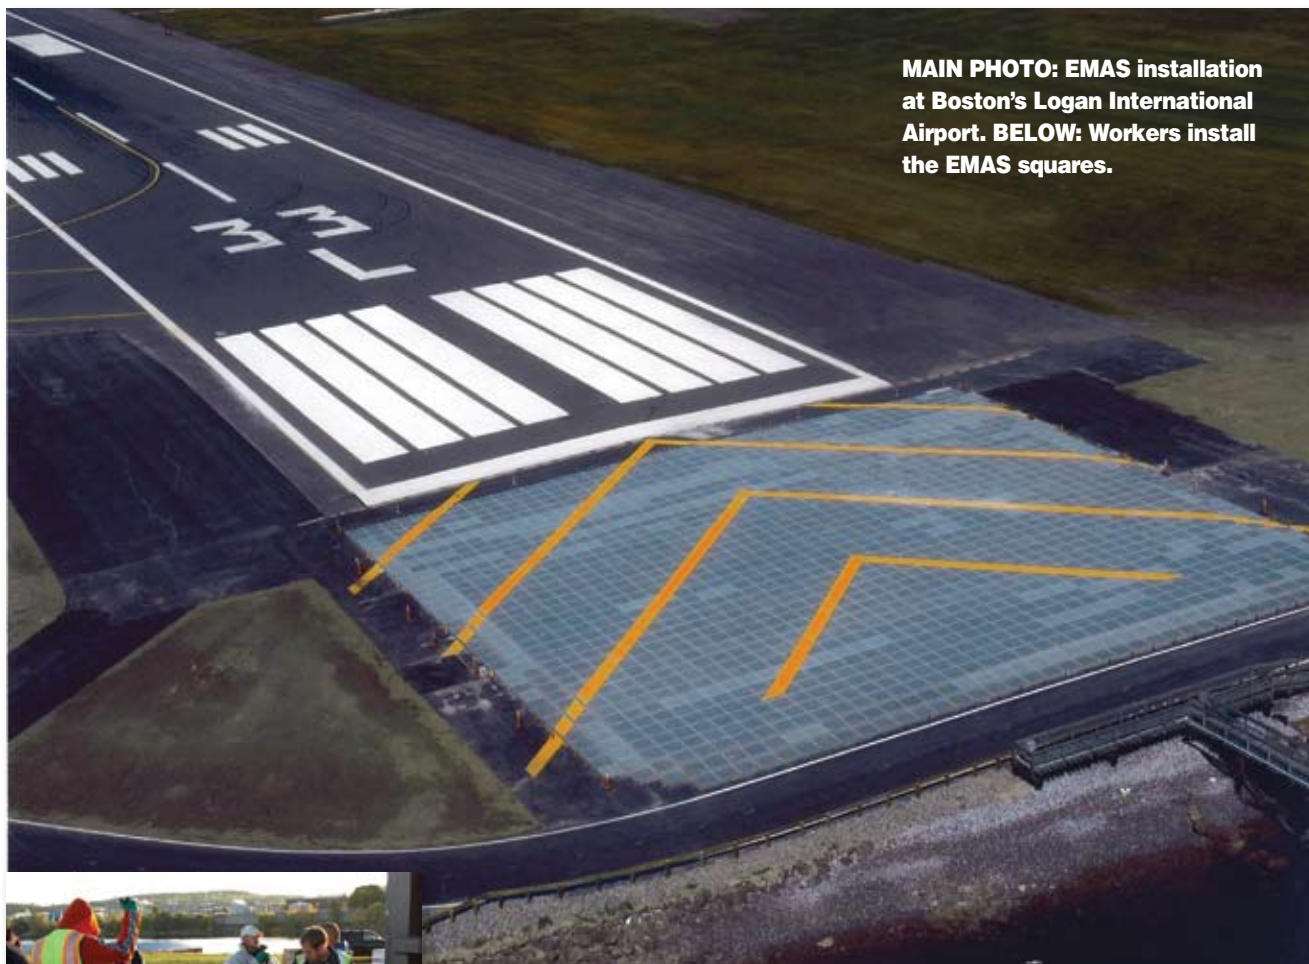
MAIN PHOTO: EMAS installation at Boston's Logan International Airport. BELOW: Workers install the EMAS squares.
