# Runway RISKS

Reducing Incursions, Excursions, and Confusion

## Air France Flight 358, Toronto, Ontario, August 2, 2005

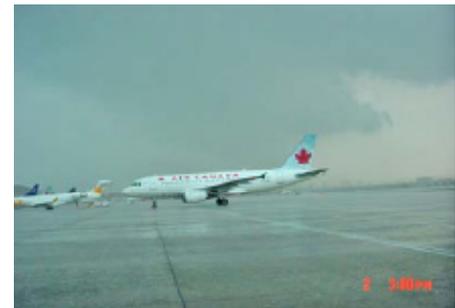
*Weather at threshold about two minutes before landing.*

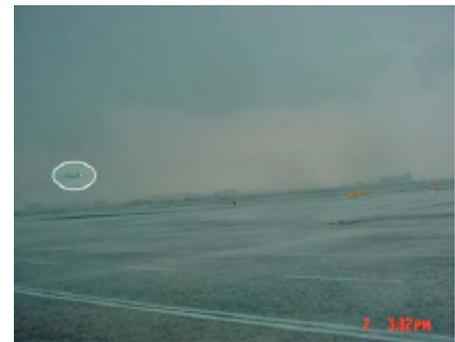
*AFR358 on short final.*

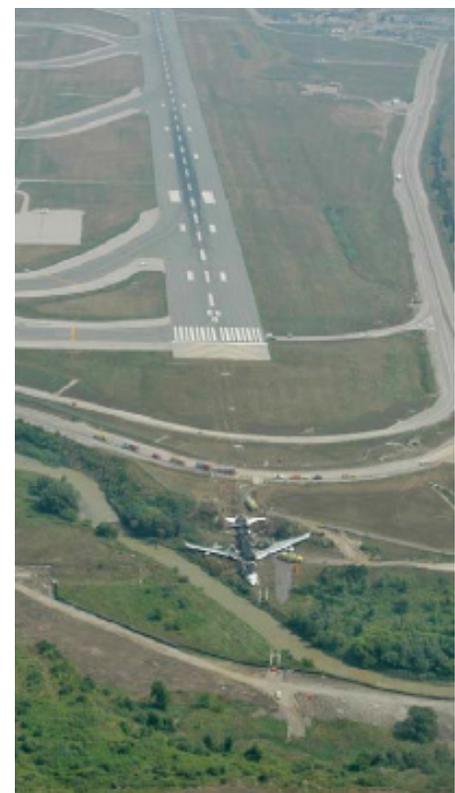
about 3,800 feet down the runway, reverse thrust was selected about 12.8 seconds after landing, and full reverse was selected 16.4 seconds after touchdown. The aircraft was not able to stop on the 9,000-foot runway and departed the far end at a groundspeed of about 80 knots. The aircraft came to rest in a ravine at 2002 UTC (1602 eastern daylight time) and caught fire. All passengers and crew members were able to evacuate the aircraft before the fire reached the escape routes. A total of two crew members and 10 passengers were seriously injured during the crash and the ensuing evacuation.

*Photos from TSBC accident report.*
